Manhole Inspection Summary

Manhole # S59U__004MH

Insp Date: **11/25/08 9:29 AM**

Location Address: **4700 Holabird Ave.**

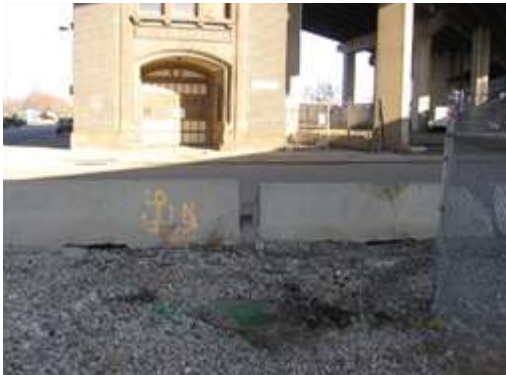
Location View

Comments **MANHOLE LOCATED AT OLD SIDEWALK. NOW COVERED IN OLD RUBBLE AND ROCKS. BEHIND A FEW CONCRETE JERSEY BARRIERS USED FOR CONSTRUCTION.**

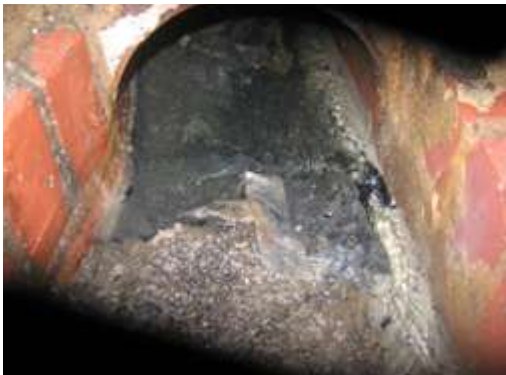
Defect 3

Condition: ☐ Sound ☐ Cracked ☐ Root Intrusion ☐ Deteriorated ☐ Leaks ☒ **Debris**

debris in channel and outgoing 12

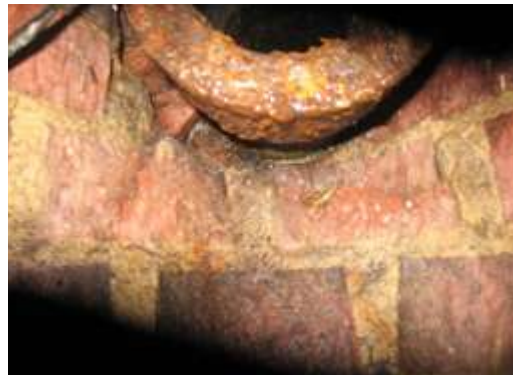
Defect 1

broken pipe seal incoming 8 o'clock

Pipe Seal Cond: **Broken**

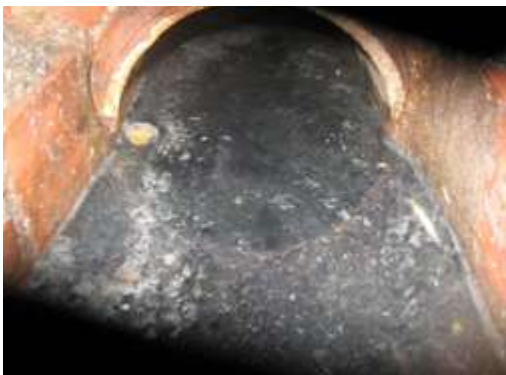
Defect 4

debris in channel and incoming 6

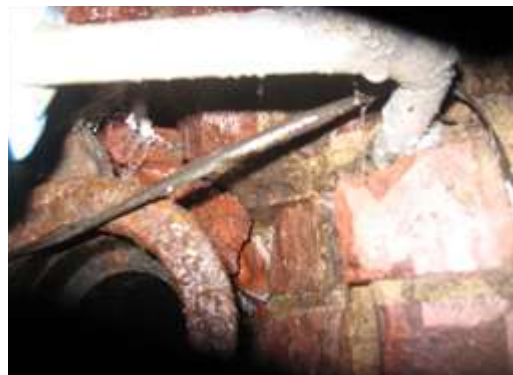
Defect 2

Condition: ☐ Sound ☐ Cracked ☐ Root Intrusion ☒ **Loose Brick** ☒ **Deteriorated**

Infiltration: ☐ None ☒ **Joint** ☒ **Cracks** ☒ **Mortar** ☐ Roots ☒ **Wall**

crack around incoming 8 and step

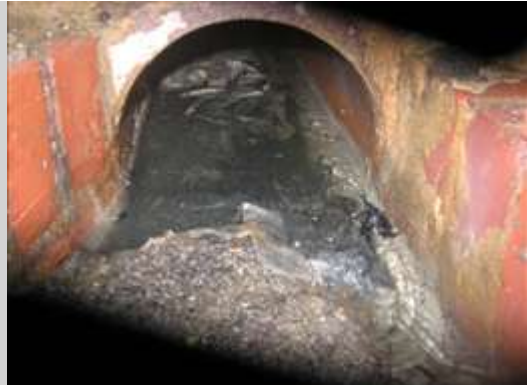
12 O'Clock Outflow

outgoing 12

Pipe Height: **8.4** (in.) Rod and Bar (Angled)
Pipe Material: **Clay** ☐ Pipe Lined
Invert Depth: **13.00** (ft.) Flow Characteristics: **Slow**
Deposits: ☐ None ☒ Mud ☒ Sludge ☒ Debris ☐ Grease
Silt Depth: **0.5** (in.) Deposits Extent: **Medium**
Infiltration: **None** Pipe Seal Cond: **Sound**

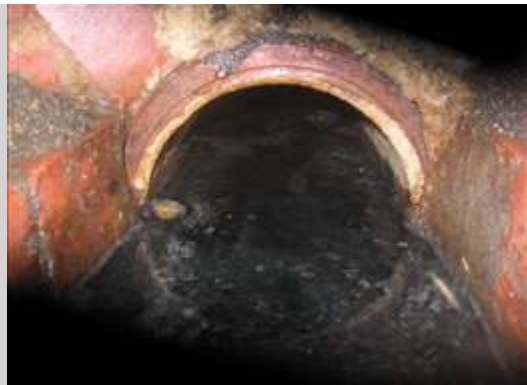
6 O'Clock Inflow

incoming 6

Pipe Height: **8.4** (in.) Rod and Bar (Angled)
Pipe Material: **Clay** ☐ Pipe Lined
Invert Depth: **12.75** (ft.) Flow Characteristics: **Slow**
Deposits: ☐ None ☒ Mud ☒ Sludge ☒ Debris ☐ Grease
Silt Depth: **0.5** (in.) Deposits Extent: **Medium**
Infiltration: **None** Pipe Seal Cond: **Sound**

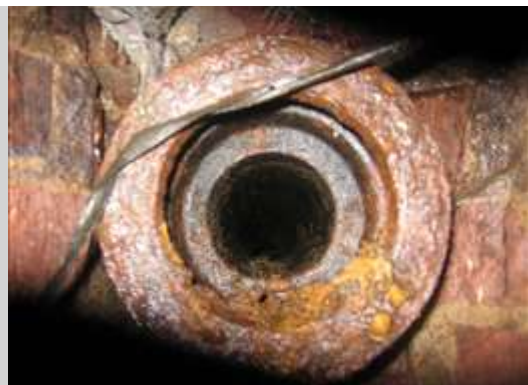
8 O'Clock Inflow

incoming 8

Infiltration: **Weeper**
